# Manhole Inspection Summary

Manhole # S17W\_\_007MH

Insp Date: **12/2/08 1:39 PM**

**Location** Address: **1601 SPENCE ST**

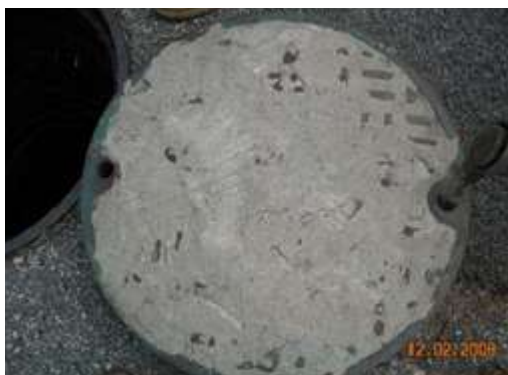
Miscellaneous

Condition: **Worn**

WORN COVER

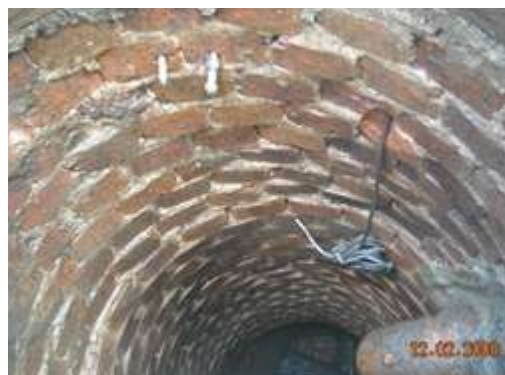
MISC.

Comments **STEAM IN LINE MADE IT DIFFICULT TO OBTAIN PROPER PIPE PICTURES.  
PREVIOUSLY OCCUPIED BY FLOW MONITOR**

FLOW MONITOR BOLTS/WIRE

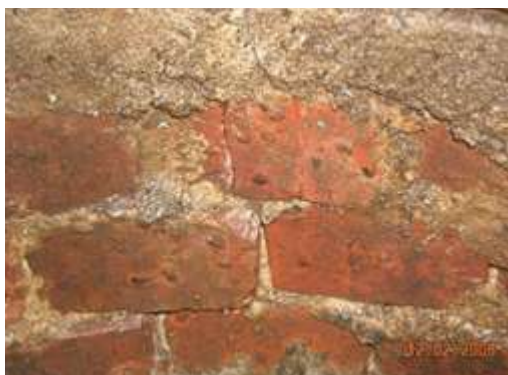
Defect 3

☒ **Cracked**

CRACKED CORBEL BRICK

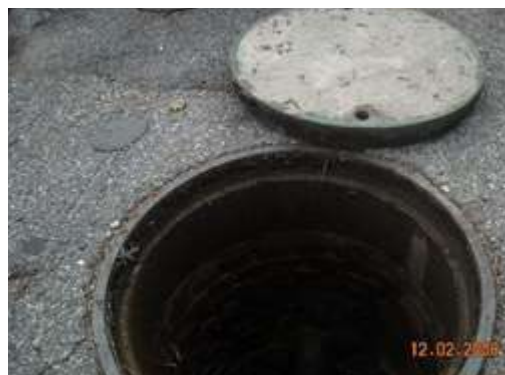
Defect

Subject To Ponding: **Sheeting**

INFLOW EVIDENCE FROM SHEETING

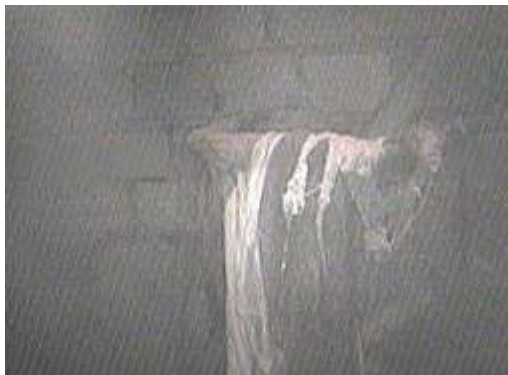
Defect 2

☒ **Evidence Of Surcharge**

Depth: **6**

EVIDENCE OF SURCHARGE

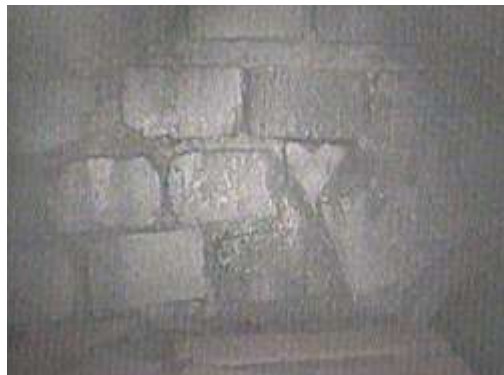
Defect 1

☒ **Wall**

INFILTRATION @ BARREL WALL

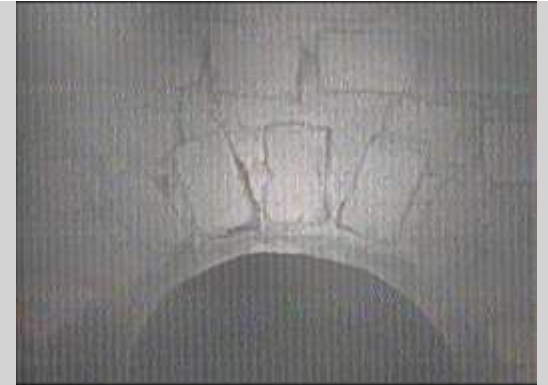
12 O'Clock Outflow

15 in. Circular Gravity Sewer  
Pipe Out @ 12 O'Clock

Pipe Height: **15.6** (in.) Rod and Bar (Angled)  
Pipe Material: **Clay** ☐ Pipe Lined  
Invert Depth: **15.85** (ft.) Flow Characteristics: **Fast**  
Deposits: ☒ None ☐ Mud ☐ Sludge ☐ Debris ☐ Grease  
Silt Depth: **0** (in.) Deposits Extent:  
Infiltration: **None** Pipe Seal Cond: **Sound**

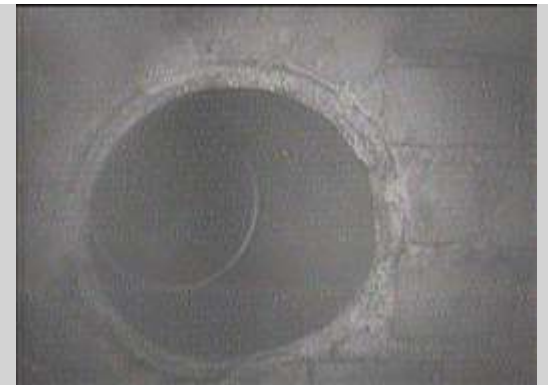
2 O'Clock Inflow

8 in. Circular Gravity Sewer  
Pipe In @ 2 O'Clock

Pipe Height: **8.4** (in.) Rod and Bar (Angled)  
Pipe Material: **Clay** ☐ Pipe Lined  
Invert Depth: **12.30** (ft.) Flow Characteristics: **Slow**  
Deposits: ☒ None ☐ Mud ☐ Sludge ☐ Debris ☐ Grease  
Silt Depth: **0** (in.) Deposits Extent:  
Infiltration: **None** Pipe Seal Cond: **Sound**

Drop: **Outside** Rod and Bar  
Angled: **Yes** Reading: **14.33** (ft.)  
Inv Depth: **15.33** (ft.)  
Drop Condition: **Open**

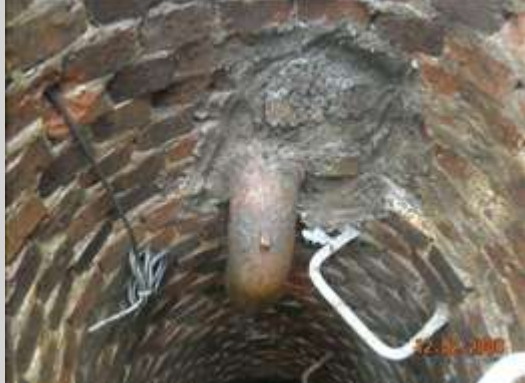
5 O'Clock Inflow

6 in. Circular Gravity Sewer

Pipe In @ 5 O'Clock

Pipe Height: **6** (in.) Rod and Bar (Angled)

Pipe Material: **DIP/CI** ☐ Pipe Lined

Invert Depth: **3.40** (ft.) Flow Characteristics: **None**

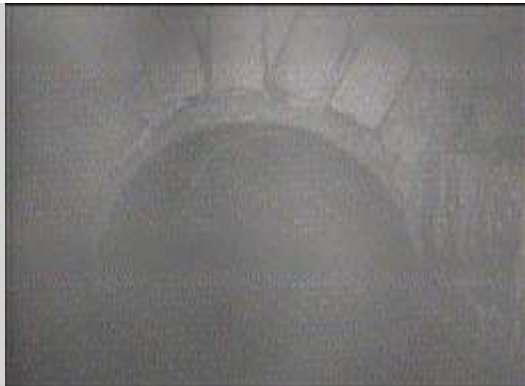
6 O'Clock Inflow

15 in. Circular Gravity Sewer

Pipe In @ 6 O'Clock

Pipe Height: **15.6** (in.) Rod and Bar (Angled)

Pipe Material: **Clay** ☐ Pipe Lined

Invert Depth: **15.90** (ft.) Flow Characteristics: **Slow**
